ICRP2018
3rd International Conference On Rebuilding Place

The Historic Timber Structure Conservation of Madrasah Idrisiah Building, Kuala Kangsar, Perak

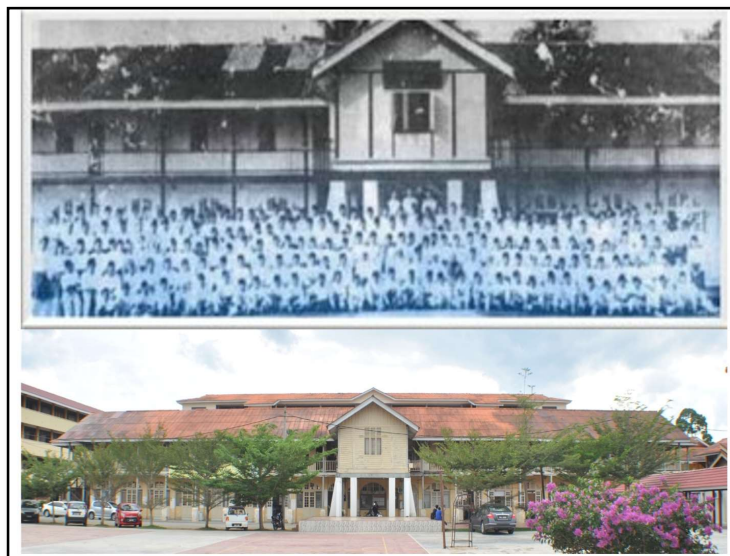
Figure 1: Top: Archive picture of Madrasah Idrisiah building with the students (Source: Madrasah Idrisiah) and below: Front view of Madrasah Idrisiah right before the conservation work started in 2017 (Source: Conservator)

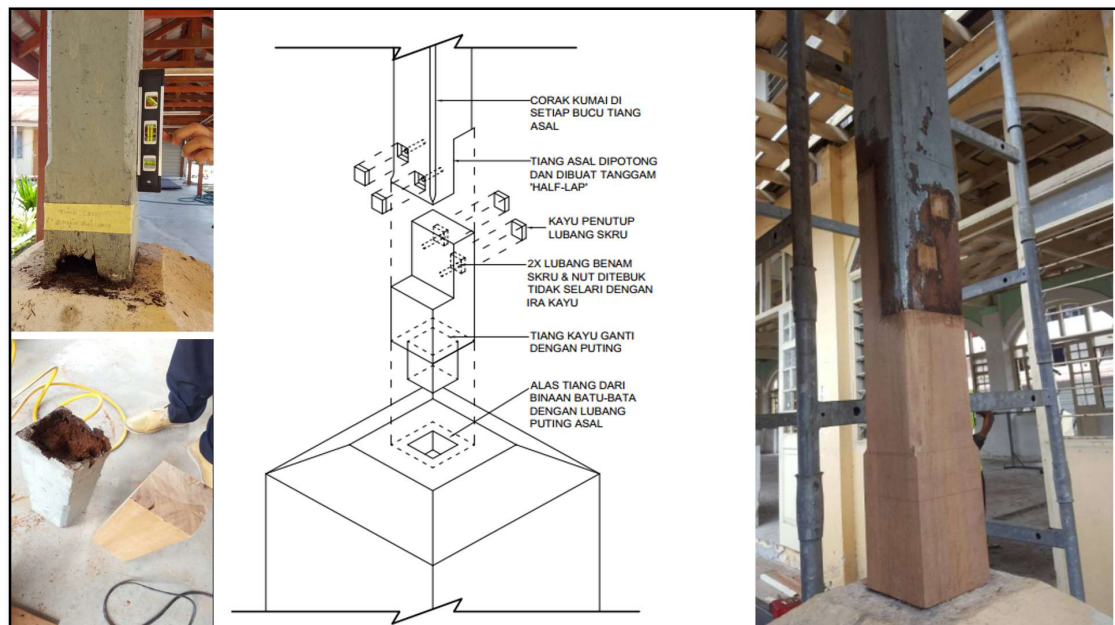
A total of 11 pillars was identified to have decayed on the jointing between masonry stumps. The cause of decaying is due to humidity and pest attack. The tenon of the pillars on stumps has been decayed and lost. See Figure 2. The consequence of this decaying causes the pillars to leaning and unstable to support the beams and joists of the first floor corridor.

Figure 2: Timber pillar defect due to deterioration. Right; timber pillars have been fragile due to pest attack. Middle; Exploded view on ‘cut and joint’ method and left; Complete timber pillar restoration

The pillars that have been cut is replaced with the new component that is duplicated according to the original, which is same properties in terms of strength and size. The new timber is needed to be dry enough and free from defects such as cracks and knots. The new pair of timber pillars are the same as the original timber species or at least from the species that most closely in mechanical properties. The original species of timber pillars used for this building are from Merbau (*Intsia palembanica*) which is classified as a hardwood (Malaysian Timber Council, 2009) (Malaysian Timber Industry Board, 2017). The jointing between the original timber pillar and the new ones by using the 'half-lap' jointing and tied with screws

and nuts, see figure 3. The screw holes need to be drilled not parallel to the timber grain (diagonal) to prevent split pole along the grain line. The screw and nut connections are concealed and patched with the same timber species with original poles. The profile pattern on the new pillar edgings is duplicated to the original pillars. This purpose is for getting uniformity in design. At the last stage, after the glue dried, the surface of the jointing is smoothen by planing and sanding the surface. The gap between the timber and the masonry stump will be inserted with waterproof glue to prevent the absorption of water in the future.

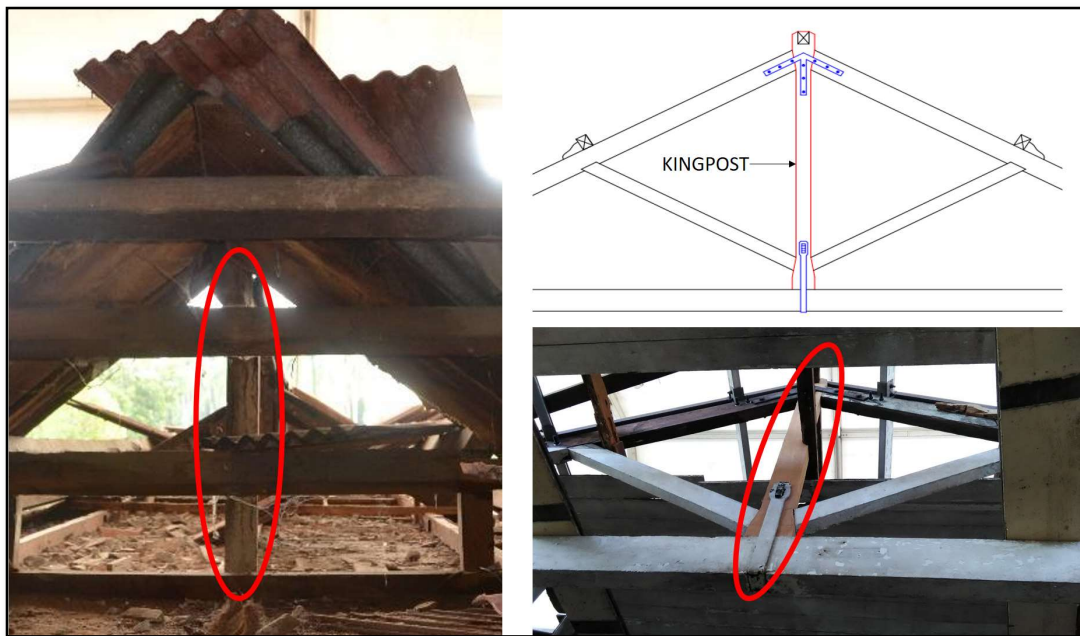
Most of the roof trusses of this building are in good condition except one of the kingpost found deteriorated suspected of roof leakage which has exposed the component with moisture. Kingpost is one of the timber members of the roof structure that stand in the middle of the truss which holds the ridge (see figure 3). All the roof truss members are tightened with its special ironmongeries. According to the 'method statement' prepared, the deteriorated kingpost should be detached from its members in order to conduct the duplication work. All the connected roof truss members are clamped accordingly before the removing deteriorated kingpost and replacing with new. The removed original kingpost is measured precisely to duplicate the new kingpost. The duplication work is not conducted on-site due to the custom made work. The new kingpost is made from the same grade of timber to remain the structure authenticity.

Figure 3: Left; Deteriorated kingpost. Right Top; Kingpost position on roof truss members. Right below; Restored Roof truss with duplicated kingpost tighten with original ironmongeries.

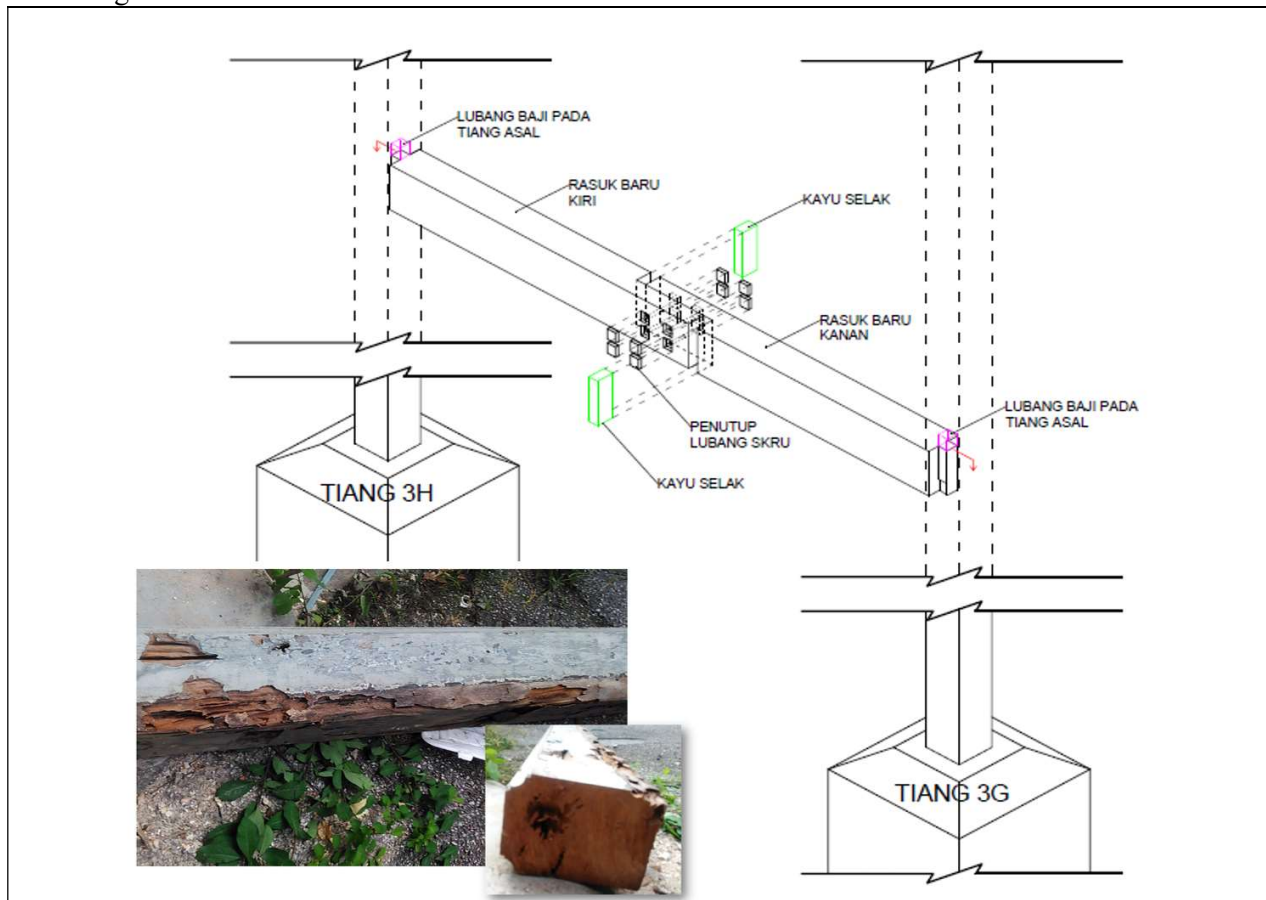
Figure 4: Diagram shows the new beam with proposed jointing in the middle in order to minimize the intervention on both pillars during restoration work. The left-below pictures show the decayed on the original beam.

out with modification on the replacing beam without obviously change its original appearance. Special jointing on the middle of the beam has been designed in order to not shifting the existing pillars as shown in the figure 4 below:

Therefore, in certain cases, the problematic timber structure should be restored on-site without dismantling the other structural members which connected. Dismantling and removing any of the existing components will bring risks to new damage. The modification of the jointing or component design itself should be necessary due to some timber restoration process are differ from the original installation process.

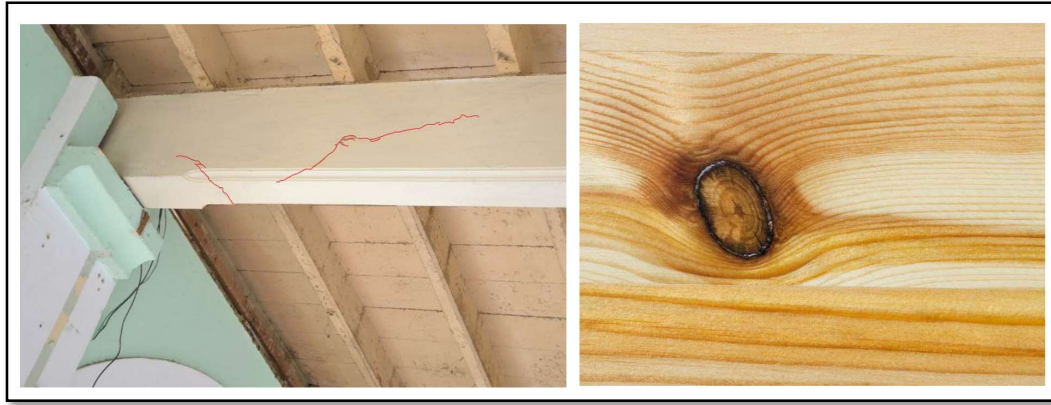
A part of the timber defects that due to moisture, there are pest attacks, timber aging problems and the deterioration of durability. There is a timber defect due to their natural growth, such as splits and crack on timber knots (spiral grain) or wavy grain, interlocking grain, hollow timber and high dense timber. The timbers that have natural defects, should not be used in construction. There is a beam in the Madrasah building that has experienced natural defect caused fractures on knots. The timber beam needs to be preserved to ensure that the structure does not deteriorate and less strength to bear the loads from the top floor.

Figure 5: The beam number 18 has cracked due to timber knots. There are knots and crack that suspected can cause the beam to bend and will eventually break. Right: example of timber knots
(<https://www.woodworkingnetwork.com/best-practices-guide>, 2017)

The proposed conservation method is by straightening and raising beam no. 18 to its original position with an additional steel plate. This method is intended to reinforce the first floor structure by using a custom steel plate. For security purposes and structural strengthening, the temporary steel prop is installed to transfer the beam's loads directly to the ground. The dropped beam is slowly jacked up until reach to its original position without damaging the other original components. The temporary steel prop is remain in use until the iron plate installation is completed. The surface of the beam is slightly cut and planed according to the shape of the steel plate. The width and length of the steel plate must have covered the cracked area. The holes are drilled through the beam matched with holes on the custom steel plate. The holes are avoided from being drilled on critical parts (cracks and knots). The steel plate shapes and thicknesses, as well as the size of the screws, are according to the engineer's recommendations. The steel plate should have located above the masonry column to help send the loads directly through it. After the installation of the steel plate, the plywood is cut according to the same shape is used to cover the exposed plate screws. The direction of the woodgrain of the plywood board should be in line with the original timber beam grain direction. Plywood attached with glue and wood putty/filler before applying the proposed finishing.

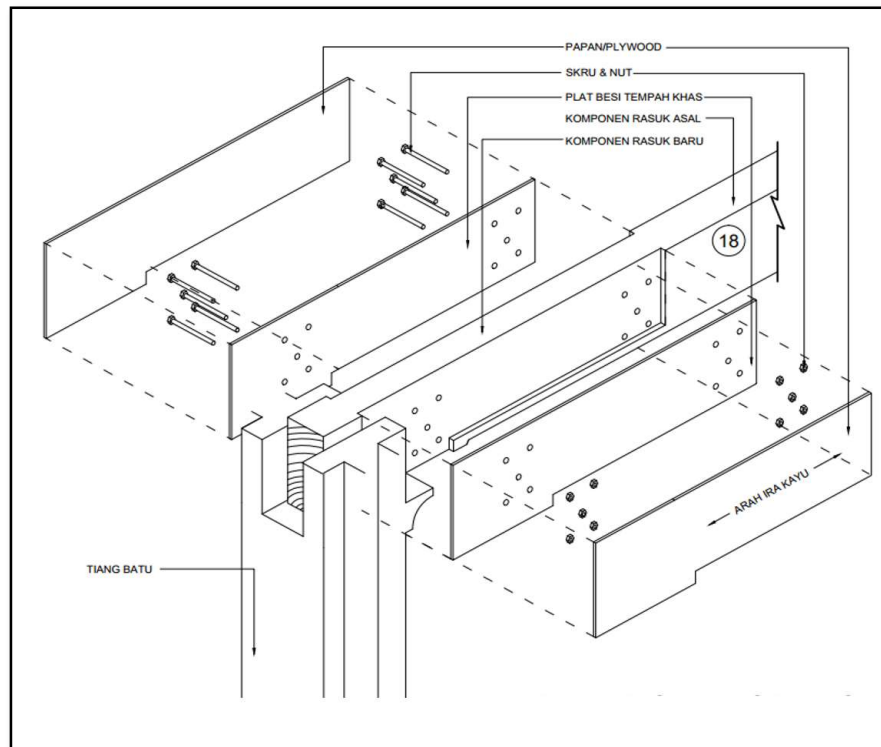
Figure 6: The Installation method of steel plate on beam no.18

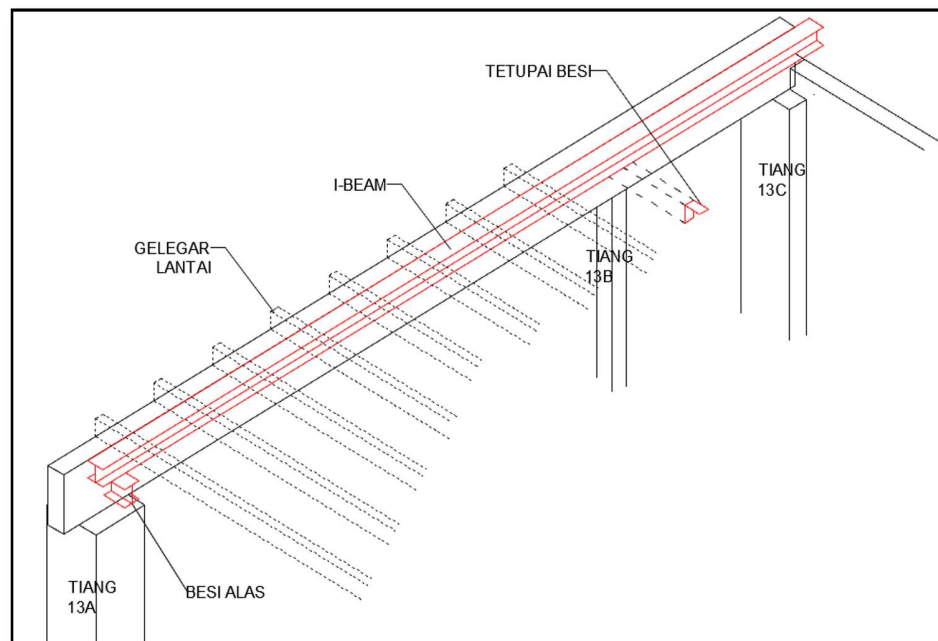
Figure 7: The new I-beam takes over the original timber beam by transferring the floor joist loads. The original exposed timber beam is preserved for aesthetic authenticity.
